NSWC/WOL/TR 76-159

THE CAUSE OF EXPLOSIONS IN OLD MK 102 MOD 0 BATTERIES UNDER DISCHARGE

BY  
L.E. DeVries

12 APRIL 1977

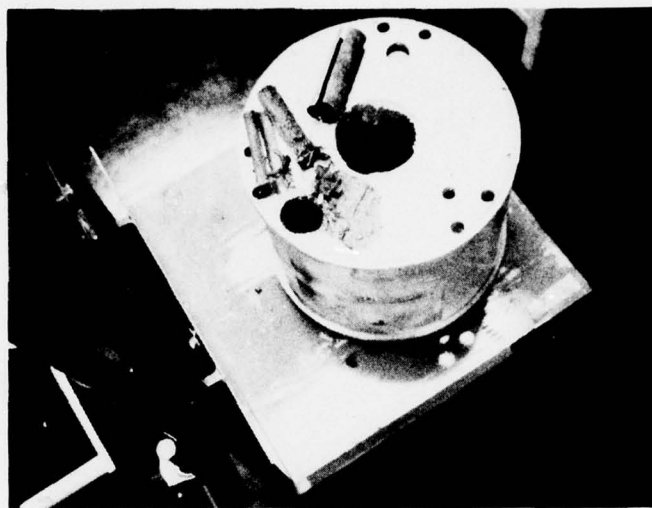
FIG. 1 BATTERY SN 705 SHOWING HOLE BLOWN IN BASE

a. PIECES BLOWN FROM CELL POINTING AT BLOWN HOLE

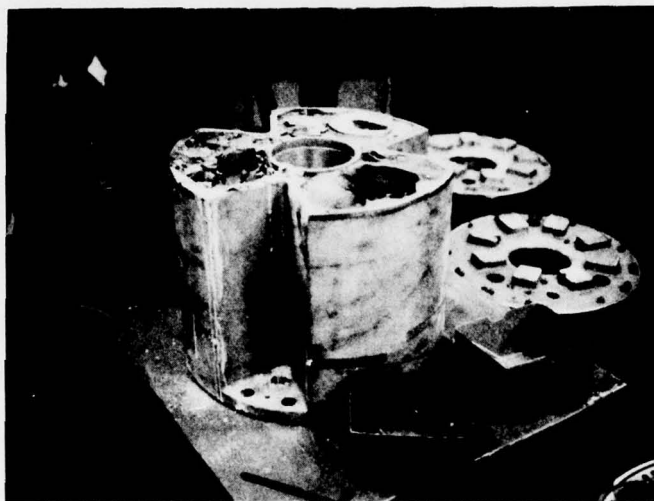
FIG. 2 BATTERY SN 210 SHOWING HOLE BLOWN AT TOP

is coated with an elastomer and placed in the aluminum battery case. The case is then filled with an epoxy resin. Filled sections are visible in Figure 2. This type of construction can permit the slow diffusion of hydrogen out of the battery as mentioned in the last paragraph. However, this type of construction might contain enough gas when it is generated in about 100 hours of discharge to create a high pressure. When the pressure exceeds what the structure can support, an explosion occurs. In the two batteries that exploded, the gas was being generated in a time period 250 (SN 210) to 630 (SN 705) times shorter than it was formed in the cell by corrosion.

a. LID REMOVED REVEALING BROKEN POTTING AT LEFT

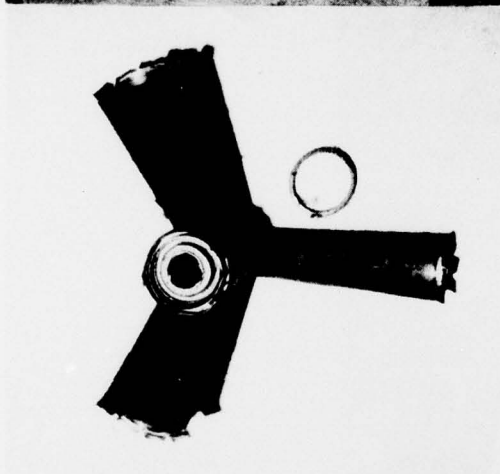
FIG. 3 UNDISCHARGED (LIVE) CELL

facilitated this reaction. Corrosion was expected in all cells, but the amount of zinc corroded had not been determined previously. The live cells contained only a small amount of liquid mercury as can be seen in Figure 3. The mercury was in the cathode. The dead cells contained a lot more liquid mercury, Figure 4. The mercury was distributed throughout the dead cells even in the zinc oxide in the anode. The large quantity of mercury in the dead cells was formed by discharge, (3). This indicates that an internal short

FEW GLOBULES  
OF MERCURY  
ARE VISIBLE

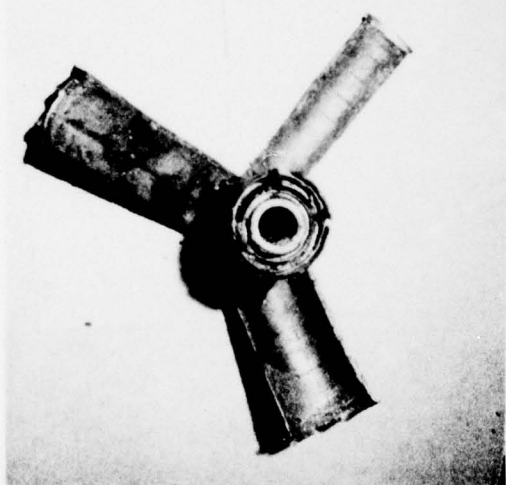
FIG. 4 DISCHARGED (DEAD) CELL

circuit in each dead cell caused the uncorroded zinc to be oxidized.

MANY GLOBULES  
OF MERCURY  
ARE VISIBLE
